Platinum in the Glass Industry

INVESTIGATING CONTAMINATION WITH THE ELECTRON PROBE SCANNING MICROANALYSER

By R. C. Jewell, A.R.S.M., B.Sc.

Research Laboratories, Pilkington Brothers Limited, Lathom

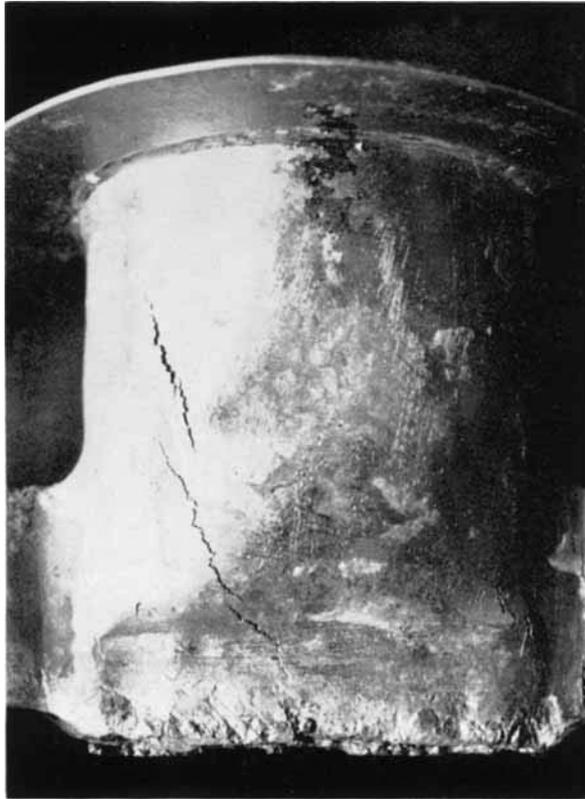
Fig. 1 Cracks in an electrically heated bushing in 10 per cent rhodium-platinum alloy. Metallographic examination revealed intercrystalline attack with signs of fusion of a contaminating phase (Fig. 2). The results of examination by the electron probe microanalyser are shown in Fig. 3

An example of this correlation is given in the following case. Molten glass from a furnace flowed into an electrically heated bushing of 10 per cent rhodium-platinum alloy maintained at 1250°C, and issued as a ribbon of glass from a rectangular slot at the base of the bushing. After a time a leak developed in the side of the bushing. The glass flow was stopped and the bushing removed for examination. Two cracks were seen as shown in Fig. 1. The alloy was brittle near the crack and a metallographic examination of a transverse section revealed intercrystalline attack with signs of fusion of the contaminating phase, as shown in Fig. 2.

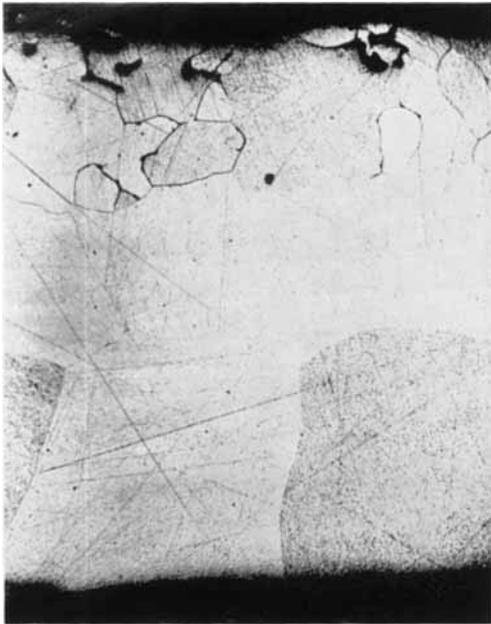
Fig. 2 Microstructure of the contaminated rhodium-platinum bushing showing intercrystalline attack and signs of fusion. ($\times 100$)

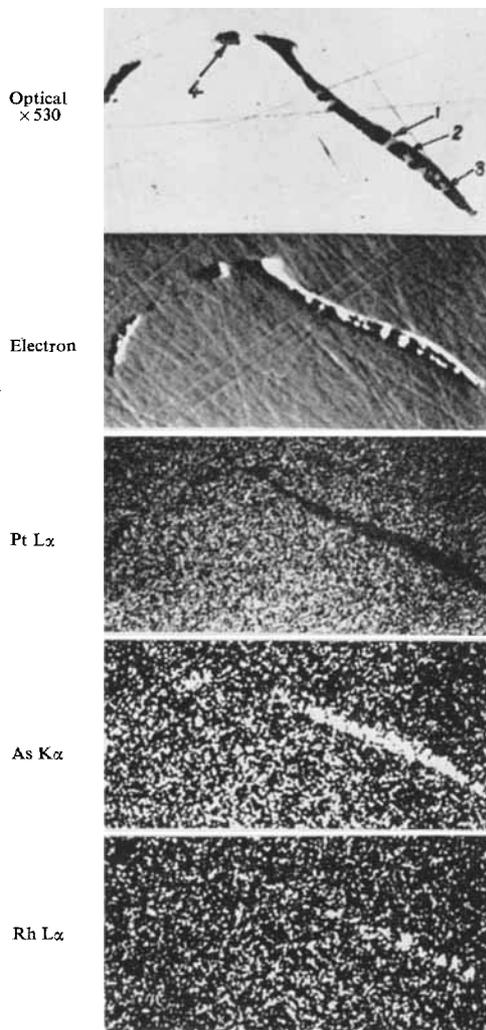
The etched microstructure, at high magnification, of the intercrystalline contaminating phase is shown at the top of Fig. 3. There appear to be two constituent phases, one etching dark at points 2 and 4, and the other etching light at points 1 and 3. The photograph immediately below shows the electron image of the same area in the X-ray microanalyser. The similarity to the optical image is readily seen. The X-ray images show the distribution of arsenic, platinum and rhodium in the respective photographs towards the bottom of Fig. 3. No contaminant other than arsenic was detected, so what were the two phases seen in the optical and electron image? Quantitative analysis of the dark phase at points 2 and 4 gave the result:

Arsenic	20 per cent
Rhodium	20 per cent
Platinum	50 per cent

and of the light phase at points 1 and 3 as:

Arsenic	20 per cent
Rhodium	45 per cent
Platinum	35 per cent

Thus both regions were alloys of arsenic-rhodium-platinum, but the light etching region was considerably richer in rhodium than the darker, more readily etched alloy. Arsenic both embrittles and lowers the melting point of rhodium-platinum and this

Fig. 3 Examination by X-ray microanalysis of the contaminant phase in the rhodium-platinum alloy bushing. Arsenic, reduced from arsenic oxide present in the glass, was shown to be the cause of contamination

was the cause of the leak. When arsenic is present in a glass it is normally there in its oxide form. In this instance the arsenic oxide was reduced locally by molybdenum used as electrodes for the electrical melting of the glass and the free arsenic so formed alloyed with the platinum of the bushing.

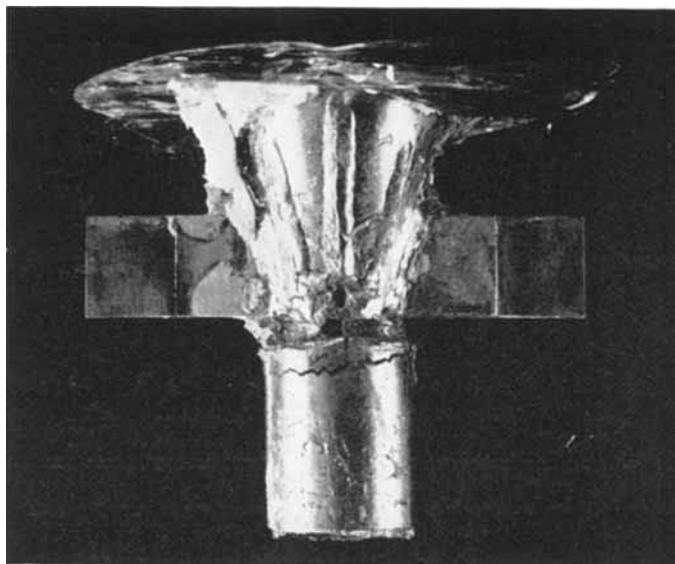
Fig. 4 Failure of an electrically heated 10 per cent rhodium-plated alloy bushing by puncture and cracking at heavily contaminated areas. Again, investigation by means of the electron probe microanalyser revealed the source of contamination--- in this case silicon

occurs more often in bottle glass production. This involved an experimental melt of glass flowing into an electrically heated cone shaped bushing with a cylindrical spout made of 10 per cent rhodium-platinum alloy maintained at 1200°C. Leaks developed resulting in molten glass dribbling down the side of the platinum alloy cone, and the bushing was removed for examination. Two leaks at the base of the cone were found and the tubular spout had cracked as shown in Fig. 4. Fused metal from the punctured areas had flowed down the outside of the tube, leaving a wake of alloy with a rippled surface terminating in a fused blob. Metallographic examination of

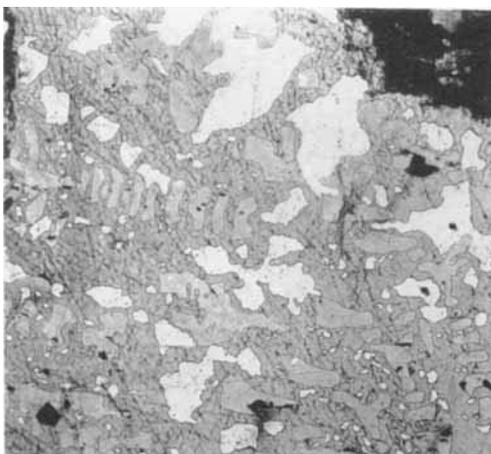
a transverse section showed heavy contamination of the rhodium-platinum by a grey dendritic phase as seen in Fig. 5. The specimen was put in the microanalyser and one arm of the dendrite was examined. The electron image at high magnification is shown in Fig. 6a. X-ray microanalysis revealed silicon as the contaminant, the X-ray image showing the distribution of silicon in the dendrite is given in Fig. 6b. The correlation with the electron image is readily seen.

Fig. 5 Microstructure of a rhodium-platinum bushing heavily contaminated by silicon. The grey areas are silicide of rhodium-platinum, the white areas uncontaminated rhodium-platinum. ($\times 150$)

dying away in the matrix of the uncontaminated rhodium-platinum. Silicon readily alloys with rhodium-platinum to form a fusible eutectic of platinum and rhodium-platinum silicide. This accounted for the fusing of the rhodium-platinum alloy at the locally heavily contaminated areas, the fused alloy then running down the tube. The associated cracking is due to the brittleness of platinum silicide.

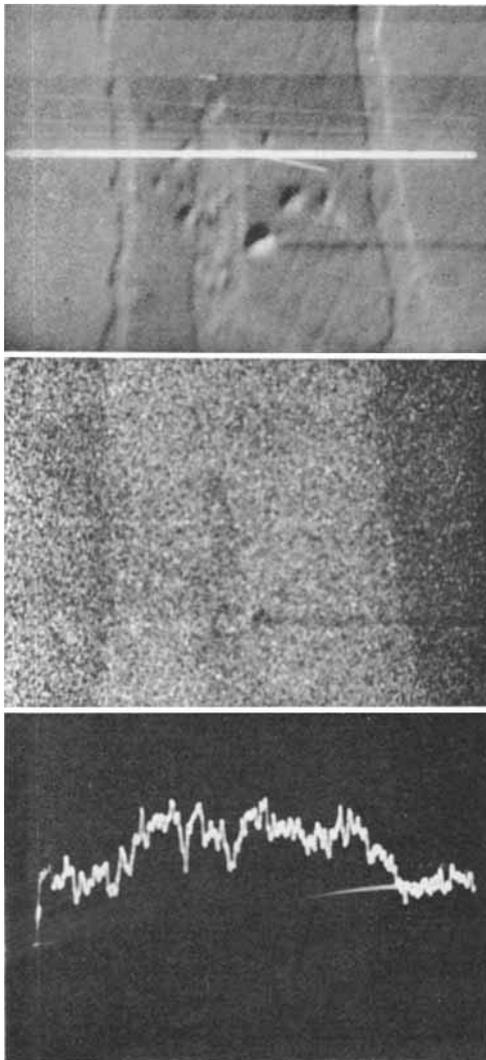
It also appeared that the centre of the dendrite had a lower silicon content than the outside layers. Fig. 6c shows the relative concentration of silicon along the path of the scan, shown as a white line in Fig. 6a, through the section of the dendrite. There is little silicon in the matrix of uncontaminated rhodium-platinum alloy, but as soon as the dendrite is reached the silicon content rises sharply, falling a little in the middle then rising again for the outside edge and finally

Fig. 6a (top) Electron image of dendrite showing line of scan ($\times 800$); 6b (middle) X-ray image of Si K α showing distribution of silicon ($\times 800$); 6c (bottom) Si K α distribution of silicon along line of scan of Fig. 6a ($\times 800$)

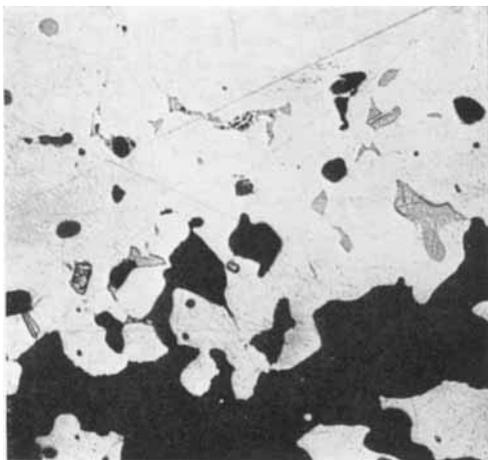
Fig. 7 Platinum contaminated by arsenic as shown by the pale grey areas. The black areas are glass inclusions ($\times 200$)

of the platinum cladding under stress. In one example of a platinum clad molybdenum stirrer, the cladding had burst and glass had run in. Metallographic examination of a transverse section cut from the platinum cladding showed a pale grey phase occurring as discrete particles and at the grain boundary, as shown in Fig. 7. Particles of glass were intimately mixed and embedded in the embrittled platinum so that it would have been impossible to eliminate all traces of glass from a sample for analysis by optical spectrograph. Since the glass contained arsenic oxide, arsenic would have been reported by this method of analysis. Arsenic certainly would embrittle platinum but a particle of glass containing arsenic (as oxide) by itself would not. The X-ray microanalyser was brought into action on the polished and etched section and by pin-point analysis the round metallic phase and grain boundary contaminant were identified *in situ* as arsenic. There was now no doubt that the arsenic revealed by this analysis was the contaminating phase in the platinum, and not the arsenic oxide present in the closely adjacent glass particles. Here again the local reduction of

the oxide of arsenic present in the glass to arsenic by the molybdenum of the stirrer led to contamination of the platinum cladding after it had burst and allowed molten glass to come into contact with the molybdenum.
