Machining Properties of Platinum

SUPERIOR PROCESS RESULTS FROM WEAR INVESTIGATIONS

By R. W. E. Rushforth

Group Research Centre, Johnson Matthey and Co Limited

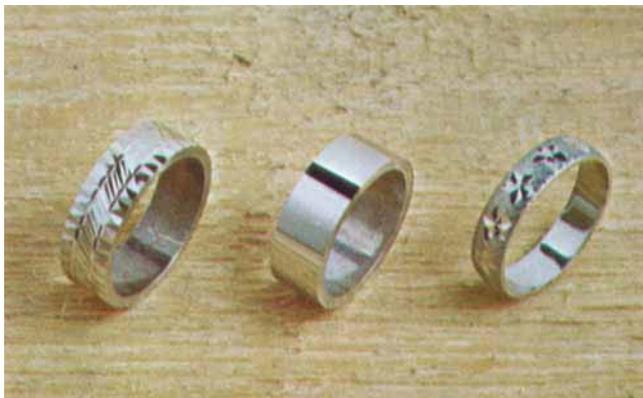
Fig. 1 One of the more obvious applications for the improved machining techniques which have been developed is in jewellery manufacture. These gloss turned and diamond milled rings show the high quality of the finish which can be imparted to the platinum surface by a diamond tool

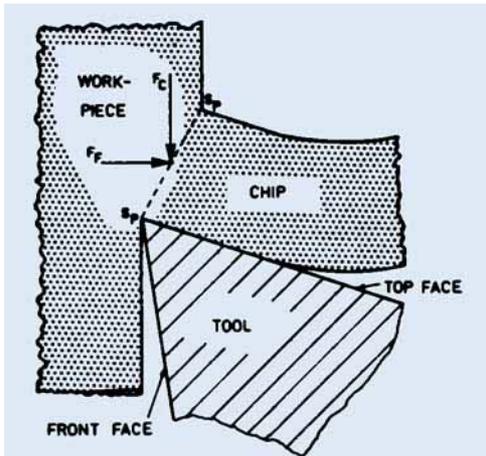
Fig. 2 Schematic diagram of the tool/workpiece interface showing the shear planes of the chip and the two main forces acting on the tool
 F_C - Cutting force; F_F - Feed force;
 S_P - Shear Plane

which take place between the workpiece and the front face of the tool and between the chip and the top face, Figure 2. Some further basic studies were therefore completed prior to examining the basic parameters of the machining process in detail.

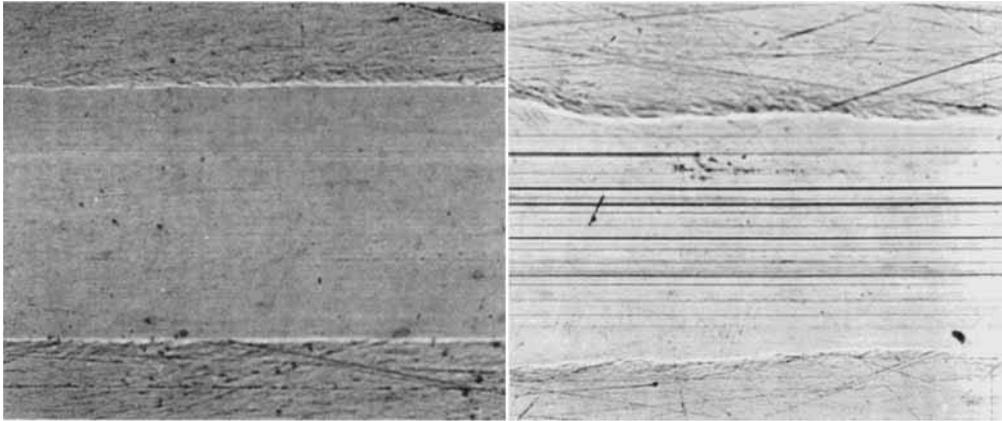
Figs. 3 (a) and (b) Grooves produced on gold (left) and platinum (right) surfaces during the coefficient of friction evaluations. The specific nature of the differences produced in these simple friction tests is typical of the behaviour patterns of the two metals in subsequent wear and machining trials × 350

The platinum and gold used for these friction determinations were both relatively soft with low yield points and under the heavier applied loads grooving of the surface occurred. Examination of these grooves showed that those formed on gold were smooth with straight parallel edges, Figure 3(a), while those formed in the platinum had irregular edges and scouring in the grooves, with the score marks sharply defined, Figure 3(b). Occasionally these score marks

would terminate in a small pile of debris. Electron probe microanalysis of this debris detected no element other than platinum and it is therefore concluded that the score marks are evidence of localised platinum to diamond adhesion.

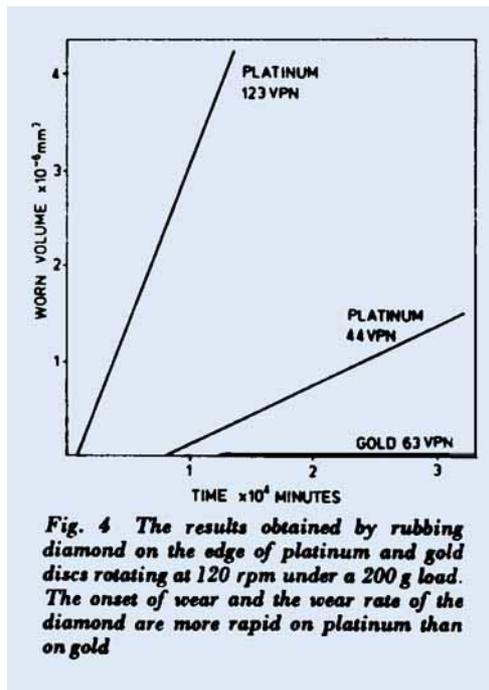
The relationship between the volume of the wear scar and time of rubbing for both work-hardened and for annealed platinum is shown graphically in Figure 4. Initially no wear takes place, and this is believed to be due to the build-up of internal stress in the surface of the diamond, but after this induction period wear progresses linearly. Clearly, annealed platinum has a longer induction period and slower wear rate than the work-hardened metal. The very low wear rate for gold, in spite of this sample being harder than annealed platinum, is well illustrated, the

steady state wear rate being about two orders of magnitude less than for platinum. Under the conditions of this wear test, temperature effects are likely to be small compared with those of the machining operation, so the heavy wear of the diamond which takes place

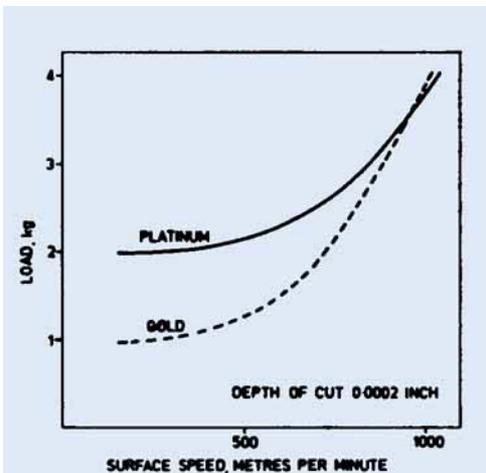
Fig. 5 The effect of workpiece surface speed on the cutting force acting on the tool. The heat generated at high speeds caused the surface of the gold test piece to smear and resulted in extremely high tool loadings

There are well established optimum cutting speeds for many of the metals and alloys that are machined; these offer the considerable advantages of minimising tool wear and improving surface finish without inducing unnecessarily high tool forces into the machining operation. Trials made with a tungsten carbide tool taking small depths of cut from workpieces rotating at all the surface speeds available showed that the forces increase with speed for both platinum and gold, Figure 5. At the higher speeds the forces generated during the machining of gold were greater than those associated with

platinum, and this is thought to be due to the tendency of gold to smear at the tool/workpiece interface under these conditions. Evidence of adhesion between platinum and the tool was obtained during these trials; Figure 6 shows a tungsten carbide tool to which the platinum chip was adhering despite the pressure of swarf build-up behind it.

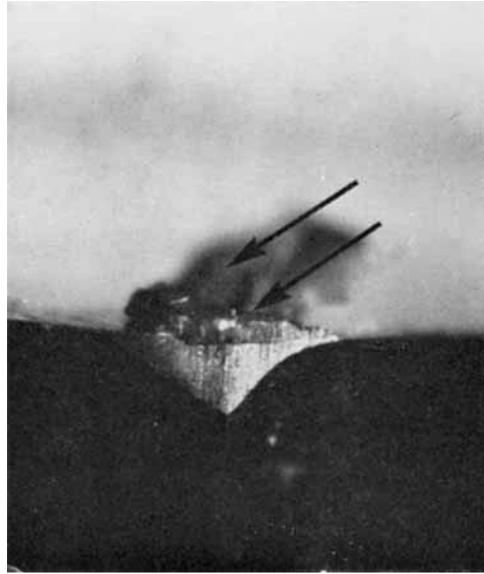
Fig. 6 An extreme instance of the adhesion of a massive chip of platinum (indicated) to the tungsten carbide tool at high workpiece surface speeds $\times 25$

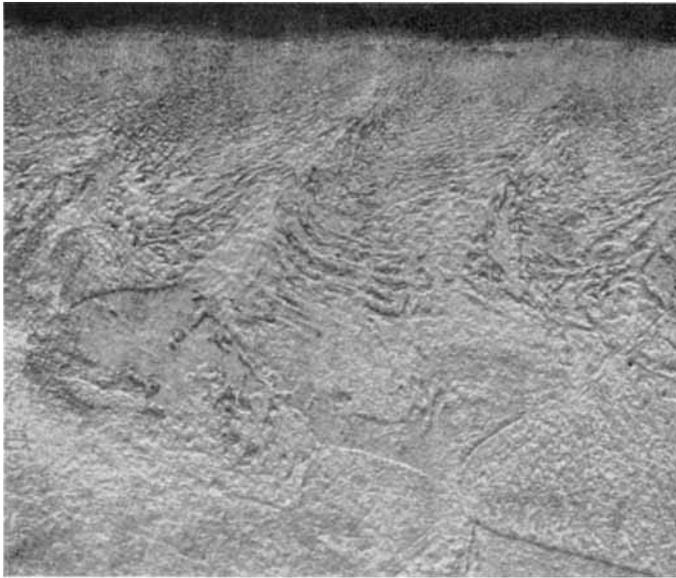
Fig. 7 The surface deformation which occurred when an annealed platinum bar was machined with a progressively wearing tungsten carbide tool. Even a single cut with a sharp tool introduces a high degree of strain into the surface of the platinum and results in a large increase in hardness
 ×200

This machining resulted in an increase in the hardness of the platinum surface from 45 to 180 VPN, while gold only hardened from 25 to 56 VPN. Metallographic examination of a section of the platinum bar showed a severely fragmented layer adjacent to the surface with a microhardness of 210 Hv, Figure 7, and the deformed zone beneath this layer gave values between 130 and 190 Hv. These hardness values are extremely high for platinum—for example the hardness of 90 per cent cold worked platinum is only 130 Hv—and indicate the degree of strain that may occur in the surface layers during machining.

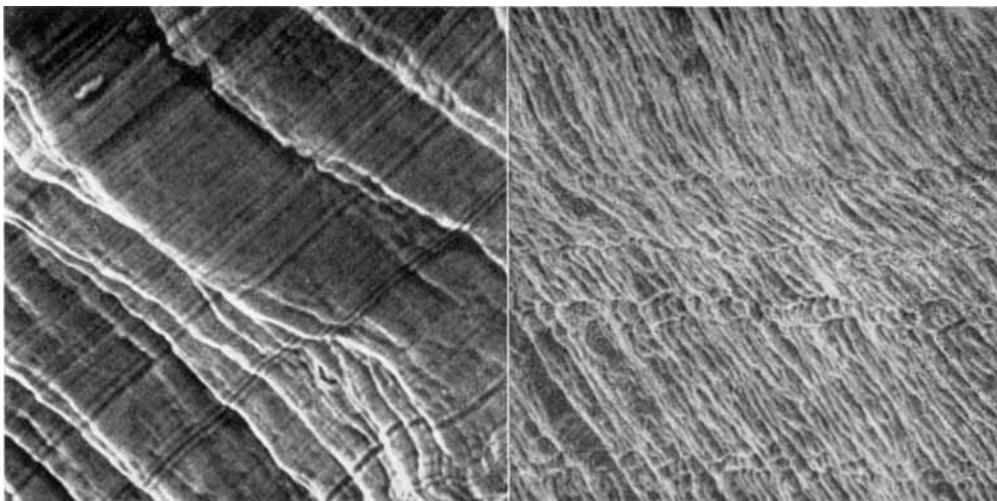
Figs. 8(a) and (b) Scanning electron photomicrographs illustrate the types of swarf produced during the machining of platinum (right) and gold (left) bars. The highly compressed platinum swarf is typical of a stick/slip tool-chip interaction × 6000

Scanning electron-microscope examination of the platinum swarf produced during these tests showed that severe chip compression had occurred, Figure 8(a). This may be compared with the gold swarf where the compression is much less, Figure 8(b). Such compression results from a stick/slip reaction

created by the chip initially adhering to the top face of the tool but then being sheared from the surface of the tool by the pressure of the oncoming chip. In severe instances particles of tool material can be removed as the adhering chip is sheared away and this results in adhesive wear of the tool.

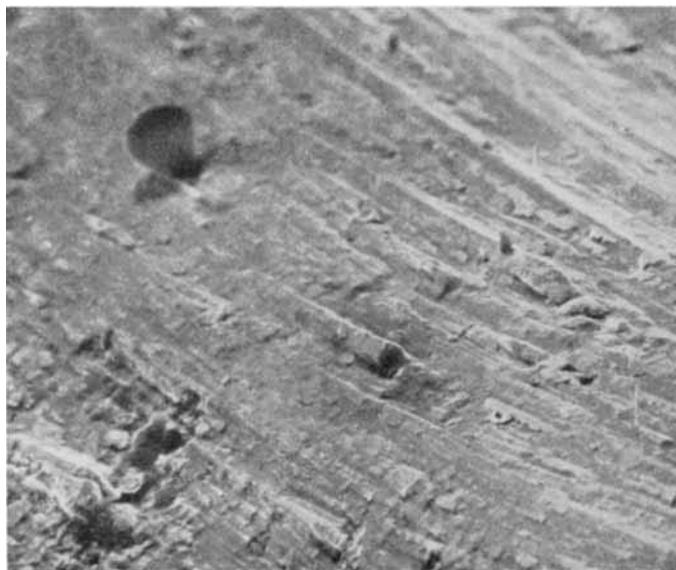
Fig. 9 The top face of a high-speed steel tool showing the results of severe stick/slip interaction with the platinum chip. The continual shearing of the adhering chip and the consequent removal of particles of tool material produce a worn and scored surface on the tool

Similar tests using high-speed steel tools also supplied evidence of this wear mechanism. A scanning electron microscope examination of such a tool used for machining platinum showed the basic features of fine grooving down the front face and a swarf scar on the top rake. Further investigation of the scar on the top face showed that particles had been pulled out of the steel by the platinum chip and then had dragged across the surface of the tool, Figure 9. The wear scar on the front face was grooved, and during machining had grown downwards from the top edge of the tool. Such grooving could be caused by fine particles of tool material being dragged down from the cutting edge across the front face of the tool. Further, microprobe

examination of the top face of the tool confirmed the presence of platinum either adhering to or embedded in the surface.

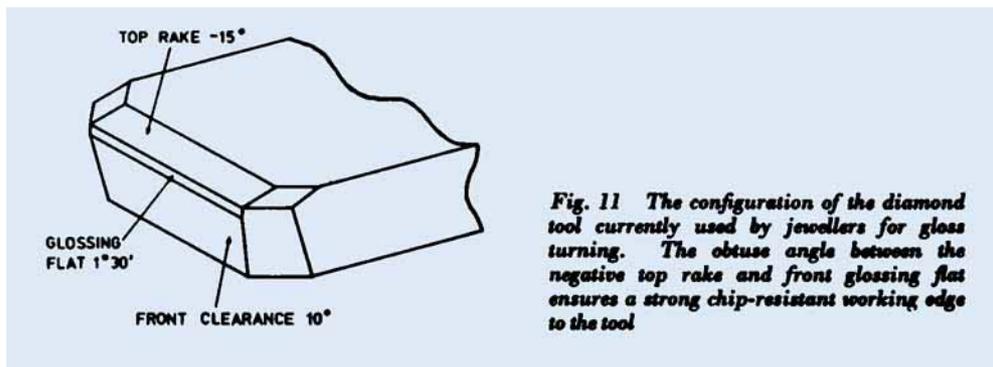
The jeweller's standard diamond lathe tool for gloss turning is shown in Figure 11. This tool has a relatively obtuse cutting edge with 15° negative top rake and a narrow glossing flat immediately below the edge. The purpose of this flat is to burnish the material after cutting and so produce a gloss surface finish. Some preliminary trials using tungsten carbide tools with a more positive top face demonstrated the advantages of such configurations for machining platinum. When

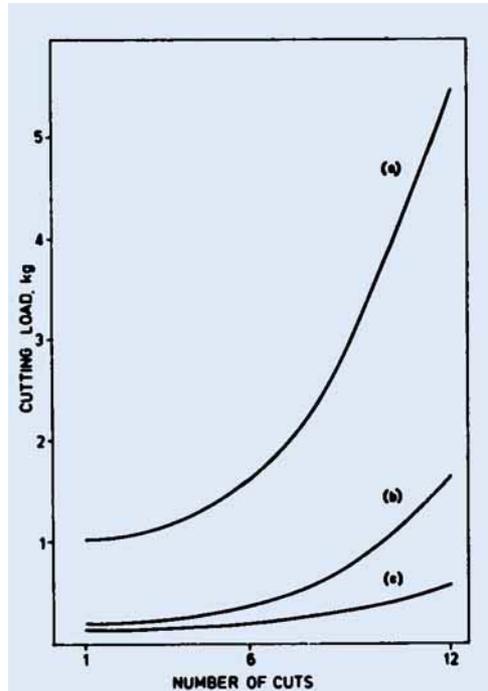
Fig. 12 Tangential loadings on tungsten carbide tools showing the reducing effect of more positive top rake, and lubrication. (a) 15° negative top rake, machined dry; (b) zero top rake, machined dry; (c) zero top rake, lubricated during machining

the top rake is changed to zero the cutting force is reduced by almost an order of magnitude and even after significant tool wear has occurred this advantage remains, as is shown in Figure 12.

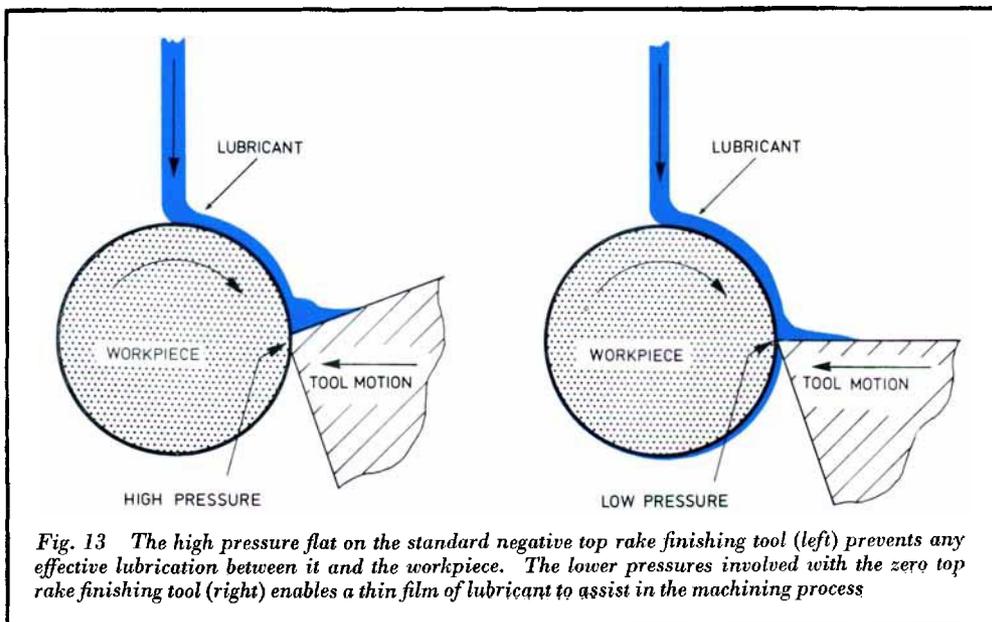
Fig. 13 The high pressure flat on the standard negative top rake finishing tool (left) prevents any effective lubrication between it and the workpiece. The lower pressures involved with the zero top rake finishing tool (right) enables a thin film of lubricant to assist in the machining process

Comparison of the negative rake configuration used by the jeweller and the zero rake diamond tools evaluated in these tests revealed a significant difference between their ability to fully utilise the lubricant applied to the platinum workpieces, Figure 13. This must make a considerable contribution to the large reduction in tool forces noted with the zero rake tools.

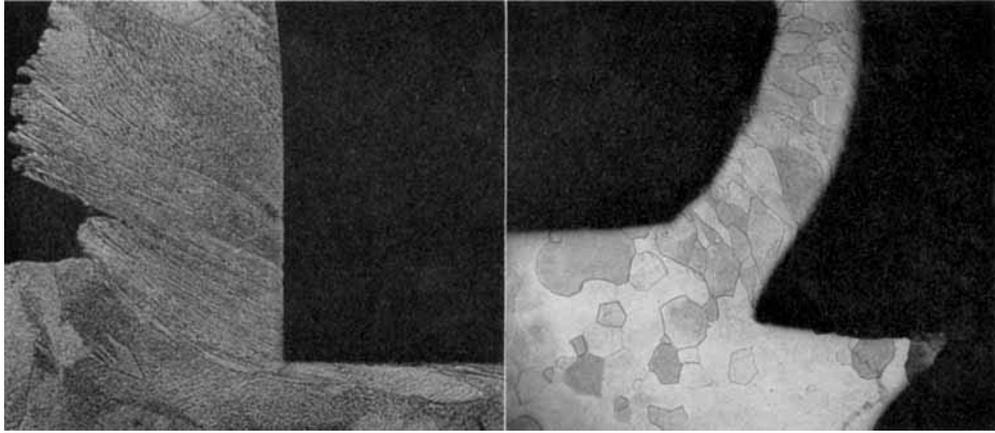
Figs. 14(a) and (b) Microsections of two annealed platinum samples subjected to an interrupted cut with a high-speed steel tool of zero rake (left) and of 40° positive top rake (right). Surface distortion and chip compression are clearly reduced by the use of more positive top rake tool configurations

A section through an annealed platinum sample subjected to an interrupted cut of 0.13 mm by this technique with a zero top rake tool is shown in Figure 14(a). Flow lines were visible along the cut edge and there was no evidence of crack propagation ahead of the tool. The chip was compressed, having been pushed ahead of the tool, with fracture occurring by shear; microhardness values showed that very high hardnesses were generated even after a single cutting operation. However, a similar experiment involving a tool with 40° positive top rake showed that a highly compressed discontinuous chip was not produced. In this instance the chip was in the form of a continuous ribbon with only slight distortion of the original grain structure, Figure 14(b).
